WATER SYSTEM REPORT

2019

Municipal Services - City of Summerside

Water System Report
January 1 – December 31, 2019
City of Summerside, Prince Edward Island
Department of Municipal Services

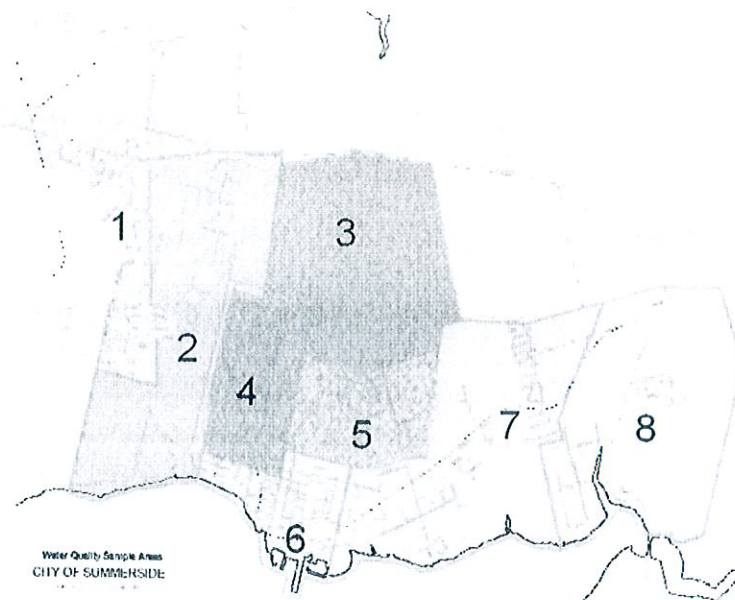
Figure 1: Summerside Water Sample Areas

The sampling zones listed in Table 1 are shown below in **Figure 1: Summerside Water Sample Areas**. These 8 sampling zones were selected according to the EPA Drinking Water and Wastewater Facility Operating Regulations. If any of the regular sampling locations are inaccessible to City staff on a scheduled sampling day, an alternate location from the same zone is sampled as a substitute.

City officials have divided the water distribution system into 8 representative areas. Water samples (one from each area as well as one from each active well) are collected and analyzed for bacteria every two weeks. The number of sample locations and frequency of sampling was determined in accordance with the Guidelines for Canadian Drinking Water Quality. **Table 1** lists below the most commonly used sample locations for 2019.
